**REPROCESSING, CARE & MAINTENANCE  
OF SURGICAL INSTRUMENTS AND ITS HYGIENIC IMPACT**

Sven Wurst  
Regional Business Manager – Surgical Asset Management

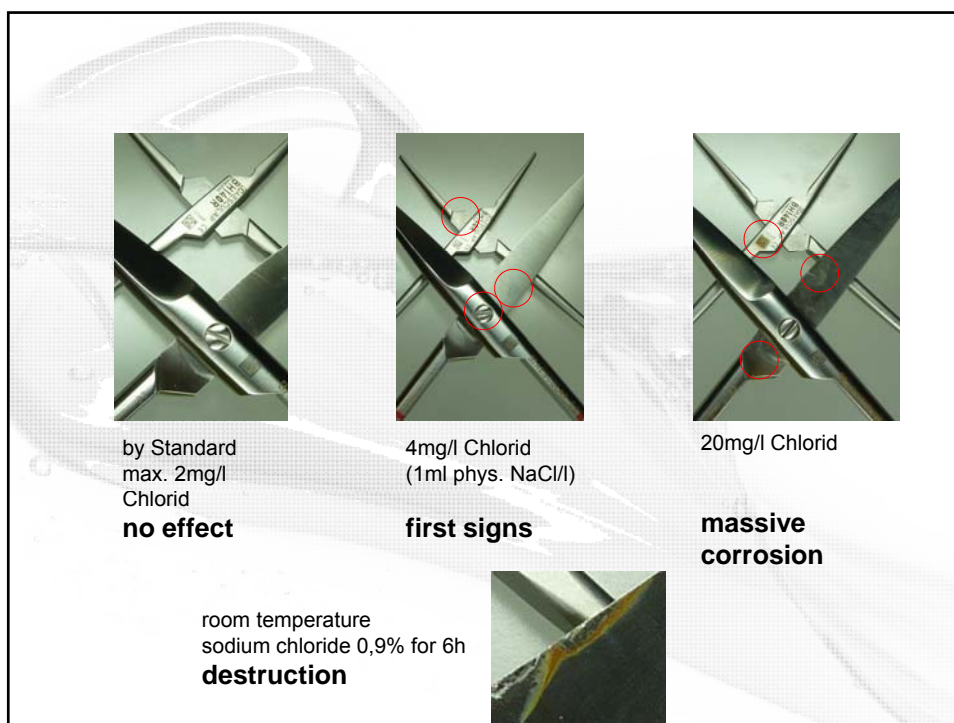
<p>by Standard max. 2mg/l Chlorid <b>no effect</b></p>	<p>4mg/l Chlorid (1ml phys. NaCl/l) <b>first signs</b></p>	<p>20mg/l Chlorid <b>massive corrosion</b></p>
<p>room temperature sodium chloride 0,9% for 6h <b>destruction</b></p>

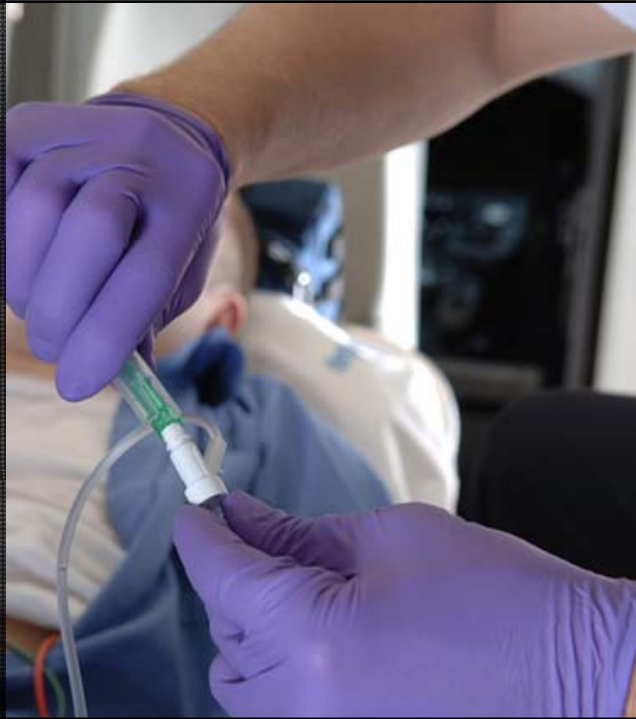
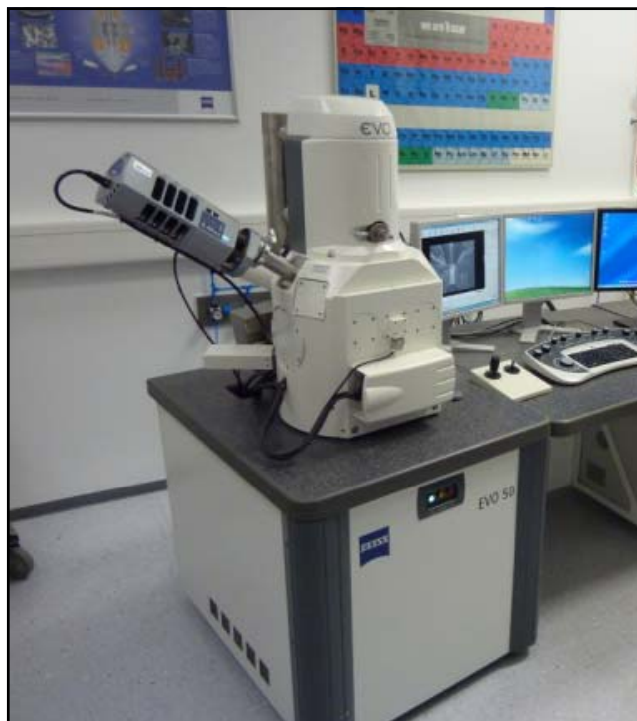
With the help of an EDX – Analysis several Instruments were part of a research study of Aesculap.

Most of the instruments effected with pitting corrosion were tested inside the pitting hole as well as on an intact reference point.

Inside the pitting holes an elevated amount of carbon as well as an oxygen concentration partially combined with Calcium, Silicon, Phosphor and sulfur was found.

This equals from a volume perspective in the measurement field 100µg of protein.
